# BELZONA RESTORES AND PROTECTS SEAWATER FILTER UNIT

ID: 9260

Industry: Marine  
Application: SOS-Ships and Offshore Structures

Substrate: Carbon steel  
Products: Belzona 1321 (Ceramic S-Metal)

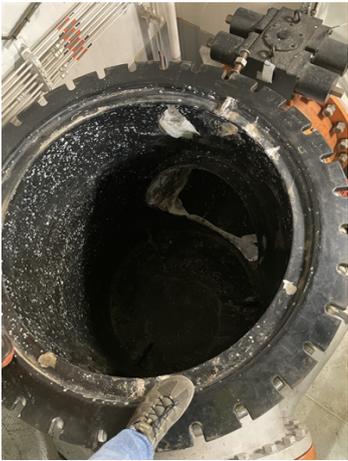
Existing internal glass flake lining of this seawater filter had failed completely. Large fragments of peeled coating was causing obstruction issues in pumps and cooling water systems.

Flaking and damaged lining

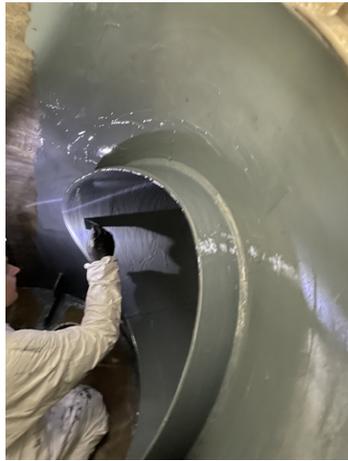
First layer of Belzona 1321 Ceramic S-Metal in progress

The surface was manually prepared using a combination of UHP water 2500 bar and rotary wire brush powered tool followed by 2 coats a 400 µm Belzona 1321 Ceramic S-metal

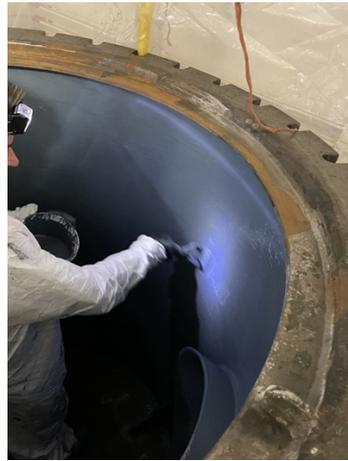
Second layer of Belzona 1321 Ceramic S-Metal in progress

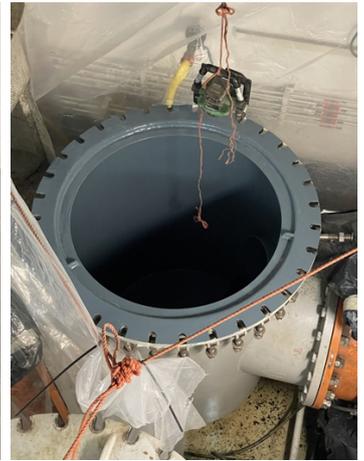
Application Completed.
