BELZONA RESTORES AND PROTECTS SEAWATER FILTER UNIT

ID: 9260

Industry: *Marine*
Application: *SOS-Ships and Offshore Structures*

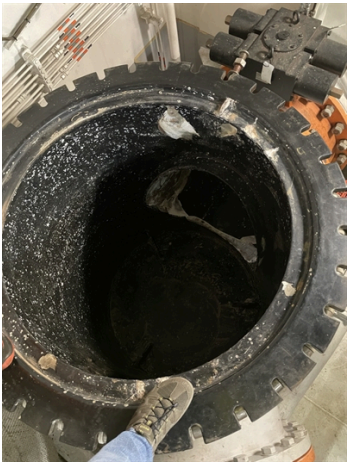
Existing internal glass flake lining of this seawater filter had failed completely. Large fragments of peeled coating was causing obstruction issues in pumps and cooling water systems.

Flaking and damaged lining

The surface was manually prepared using a combination of UHP water 2500 bar and rotary wire brush powered tool followed by 2 coats a 400 µm Belzona 1321 Ceramic S-metal

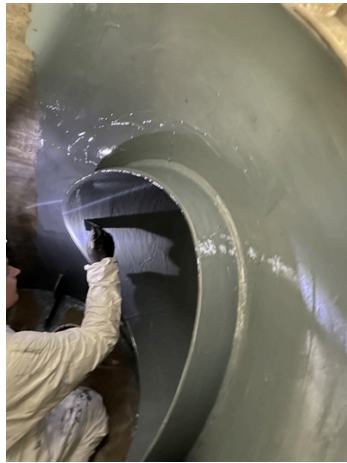
First layer of Belzona 1321
Ceramic S-Metal in progress

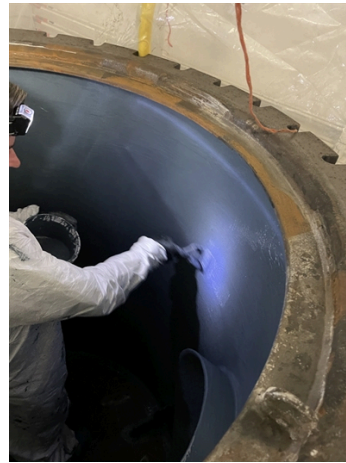
Second layer of Belzona 1321
Ceramic S-Metal in progress

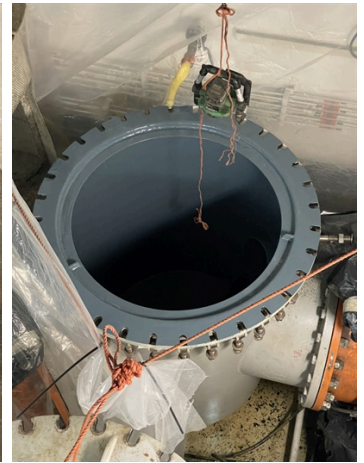
Application Completed.
