BELZONA RESTORES AND PROTECTS SEAWATER FILTER UNIT

ID: 9260

Industry: Marine
Application: SOS-Ships and Offshore Structures

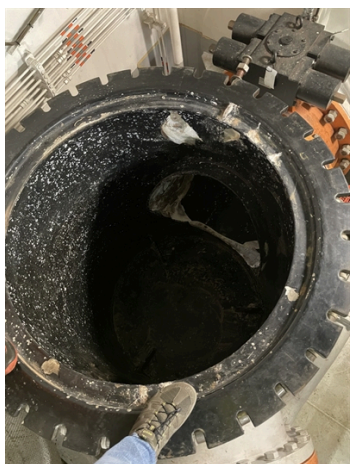
Existing internal glass flake lining of this seawater filter had failed completely. Large fragments of peeled coating was causing obstruction issues in pumps and cooling water systems.

Flaking and damaged lining

The surface was manually prepared using a combination of UHP water 2500 bar and rotatory wire brush powered tool followed by 2 coats a 400 µm Belzona 1321 Ceramic S-metal

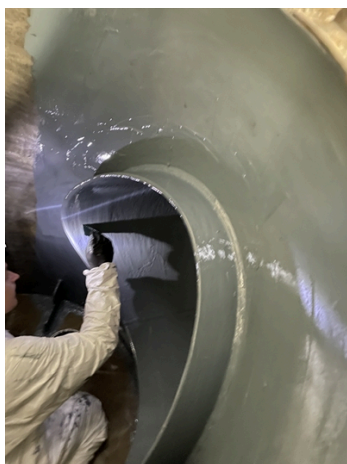
First layer of Belzona 1321
Ceramic S-Metal in progress

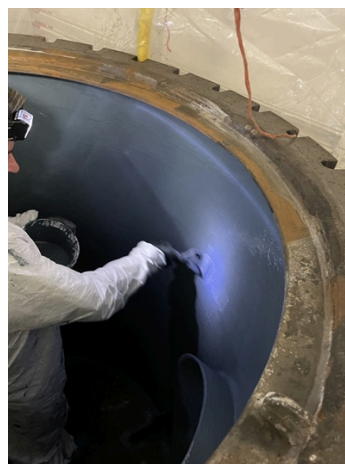
Second layer of Belzona 1321
Ceramic S-Metal in progress

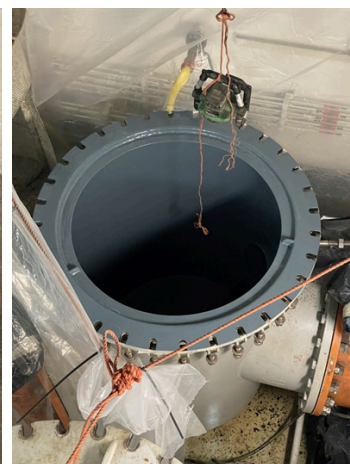
Application Completed.
