# Belzona lines a bund.

**Industry:** Steel & Metal Processing  
**Application:** TCC-Tanks and Chemical Containment Areas  
**Substrate:** Concrete  
**Products:** Belzona 4311 (Magma CR1), Belzona 4911 (Magma TX Conditioner)

**Customer Location:** Spain  
**Application Date:** July 2019

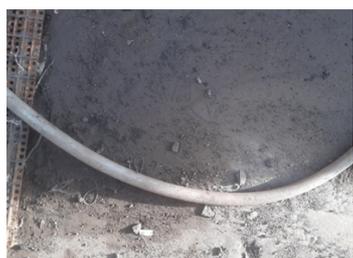
Previous exposure to the acid had caused the concrete to degrade and it was evident to the customer that this needed rectifying.

The application was carried out as per the instructions for use and the systems leaflet. With the application onto the concrete done when the surface was cooling as to minimise outgassing.
