Belzona lines a bund.

ID: 9261

Industry: Steel & Metal Processing
Application: TCC-Tanks and Chemical Containment Areas
Substrate: Concrete
Products: Belzona 4311 (Magma CR1), Belzona 4911 (Magma TX Conditioner)

Customer Location: Spain
Application Date: July 2019

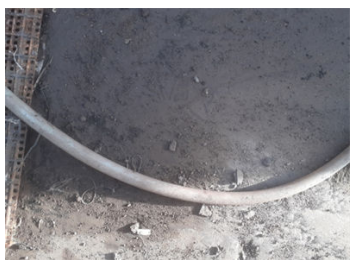
Previous exposure to the acid had caused the concrete to degrade and it was evident to the customer that this needed rectifying.

Surface Preparation

The application was carried out as per the instructions for use and the systems leaflet. With the application onto the concrete done when the surface was cooling as to minimise outgassing.

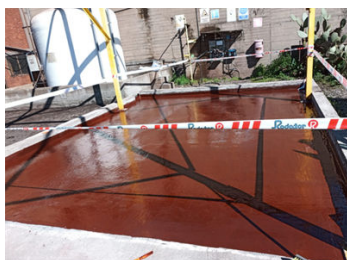
Application Completed
