BELZONA REFURBISHES DN 500 FISHFARM SEAWATER PUMPS

ID: 9264

Industry: *Marine* Customer Location: *Norway*
Application: *CEP-Centrifugal Pumps* Application Date: *June 2022*
Substrate: *Cast Iron*
Products: *Belzona 1311 (Ceramic R-Metal), Belzona 1321 (Ceramic S-Metal)*

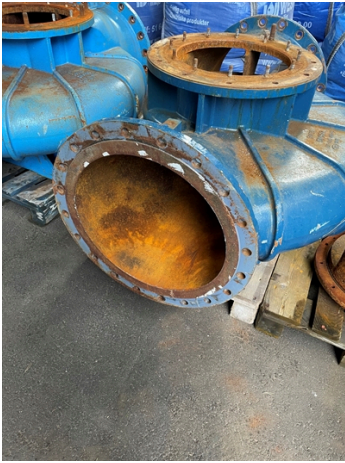
Seawater pump housings was suffering from internal corrosion and local erosion after a short period in service. In order to prevent breakdown of the pumps, the customer urgently decided to rebuild and protect the internal surfaces.

Corroded pump housings

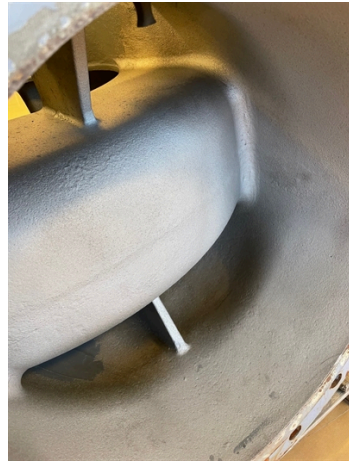
Grit blasted details

1. The pump housings was internally grit blasted to SA-2,5 with a minimum surface profile of 75 microns according to ISO 1805-1
2. Corroded and worn areas was rebuilt and restored using Belzona 1311 Ceramic R-metal
3. A second grit blasting of both internals and externals to SA-2,5 with a minimum surface profile of 75 microns according to ISO 1805-1 was carried out.
4. Internal surfaces was coated with 2 layers a 375micron of Belzona 1321 Ceramic S-metal.

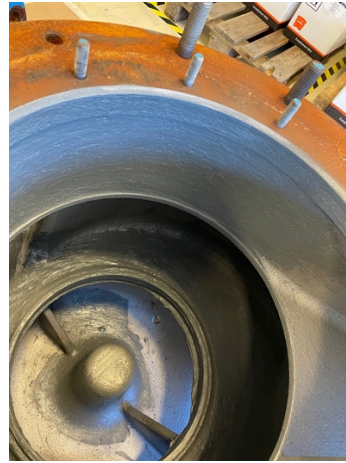
Rebuilding in progress

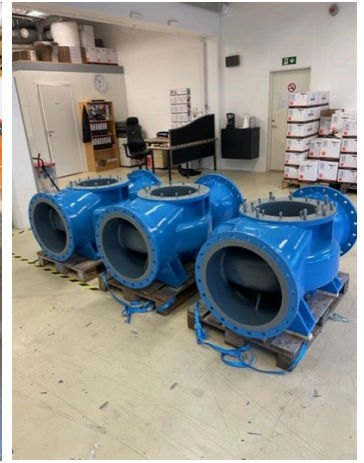
Coating application completed.
