External corrosion protection for Gas Insulated Busbar

ID: 9265

Industry: Power
Application: VPF-Valves, Pipes and Fittings
Substrate: Carbon steel
Products: Belzona 3921 (GSC Surface Conditioner), Belzona 5111 (Ceramic Cladding)

Customer Location: Scotland
Application Date: September 2023

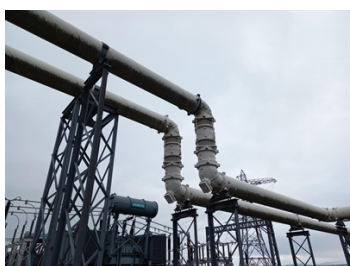
This Gas Insulated Busbar (GIB) is in an exposed coastal environment, there was concern that breakdown of the existing paint system & subsequent corrosion could occur on the flange & bolts. A system was needed to provide long term protection for these areas.

Complex geometry around the flanges

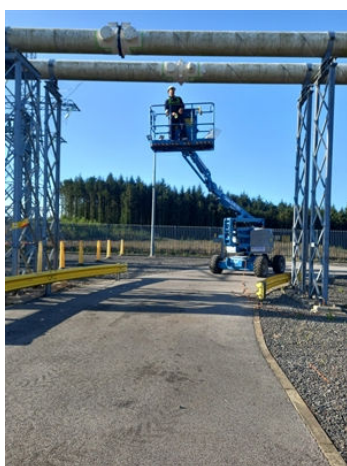
Access, cleaning & roughening of existing system

The areas were first cleaned then the existing paint system was roughened. Belzona 3921 GSC Conditioner was used as a primer followed by two coats of Belzona 5111 Ceramic Cladding.

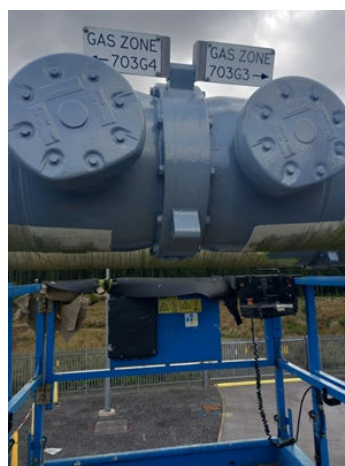
Belzona 5111 1st coat
