External corrosion protection for Gas Insulated Busbar

ID: 9265

Customer Location: Scotland
Application Date: September 2023

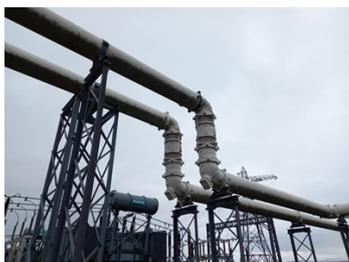
This Gas Insulated Busbar (GIB) is in an exposed coastal environment, there was concern that breakdown of the existing paint system & subsequent corrosion could occur on the flange & bolts. A system was needed to provide long term protection for these areas.

Complex geometry around the flanges
