External corrosion protection for Gas Insulated Busbar

ID: 9265

Industry: Power

Application: VPF-Valves, Pipes and Fittings

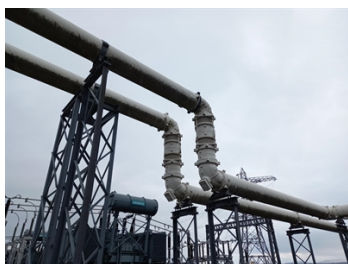
Complex geometry around the flanges

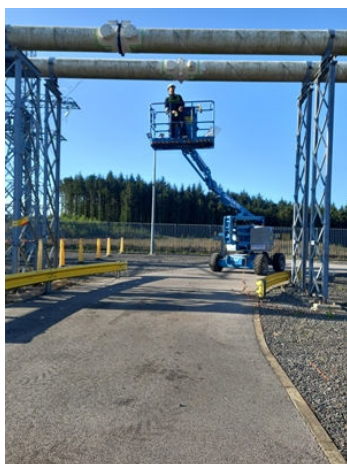
Access, cleaning & roughening of existing system

The areas were first cleaned then the existing paint system was roughened. Belzona 3921 GSC Conditioner was used as a primer followed by two coats of Belzona 5111 Ceramic Cladding.

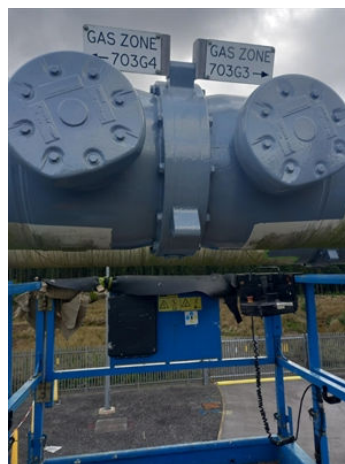
Belzona 5111 1st coat
