Belzona chiller repair that was completed in only one day!

ID: 9268

Application: HEX-Heat Exchangers

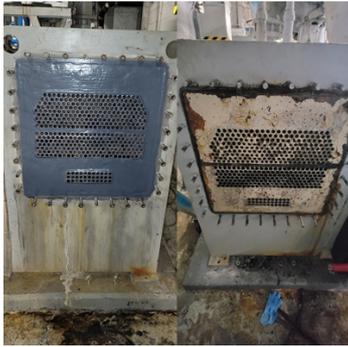
This chiller has been running uncoated since new for years in a building in downtown Dallas. Bad water treatment has left the chiller with a lot of damage and build up.

Before and after Belzona application

This chiller had no efficiency left. It was decided to do a full Belzona repair system on it. First the chiller was cleaned and then grit blasted. Belzona 1121 was used to repair holes and metal loss in the chiller face. After that Belzona 1321 two good system was applied to chiller. Belzona was left to dry and it was finished off by taking out the corks out of the tubes and finishing up the repair.

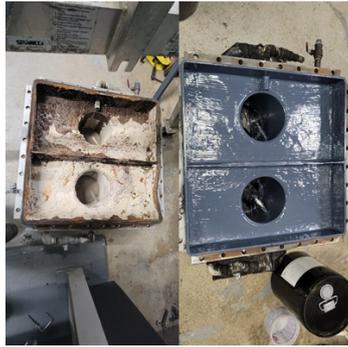
Before and after Belzona application

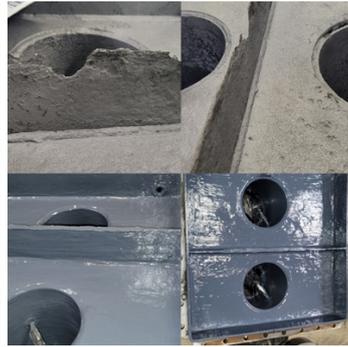
Before and after Belzona application

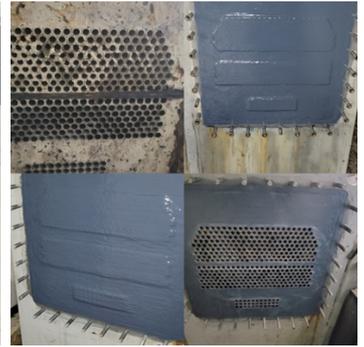
Before and after Belzona application
