Belzona chiller repair that was completed in only one day!

Application: HEX-Heat Exchangers

Application Date: February 2024

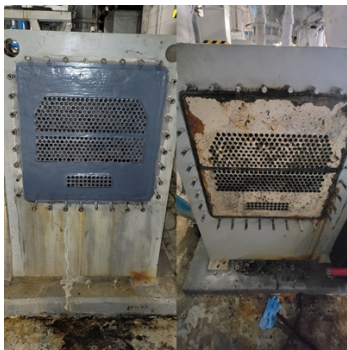
This chiller has been running uncoated since new for years in a building in downtown Dallas. Bad water treatment has left the chiller with a lot of damage and build up.

Before and after Belzona application

This chiller had no efficiency left. It was decided to do a full Belzona repair system on it. First the chiller was cleaned and then grit blasted. Belzona 1121 was used to repair holes and metal loss in the chiller face. After that Belzona 1321 two good system was applied to chiller. Belzona was left to dry and it was finished off by taking out the corks out of the tubes and finishing up the repair.

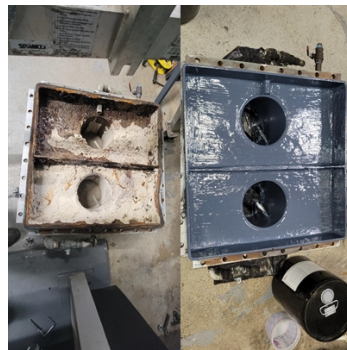
Before and after Belzona application

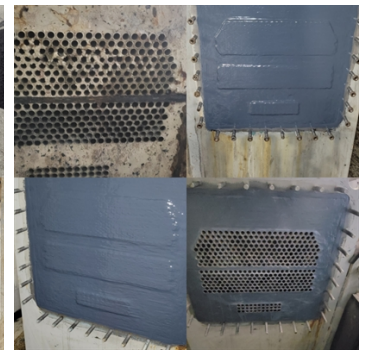
Before and after Belzona application
