BELZONA ELASTOMER REPAIRS TO AGITATOR IN FGD UNIT

ID: 927

Industry: Power

Application: SHM-Solids Handling Machinery

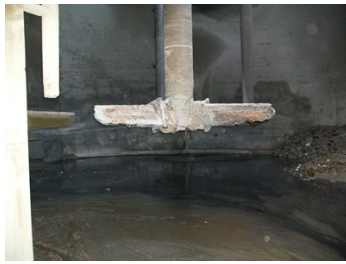
Rubber clad blades damaged through impact and abrasion. Each shaft has three blades and there were four shafts.

- * General view of the plant ,
- * The Crystallization Tank Mixer ,
- * Application crew in action ,
- * Completed application ,

Agitator blades in crystallization tank which is an important component of the Flue Gas Desulfurization (FGD) unit.

Application was carried out in accordance with Belzona Know-How System leaflet SHM-9.
