BELZONA ELASTOMER REPAIRS TO AGITATOR IN FGD UNIT

ID: 927

Application: SHM-Solids Handling Machinery

Customer Location: Power Station, Lawrence, Kansas

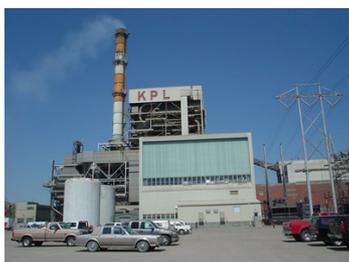
- * General view of the plant ,
- * The Crystallization Tank Mixer ,
- * Application crew in action ,
- * Completed application ,

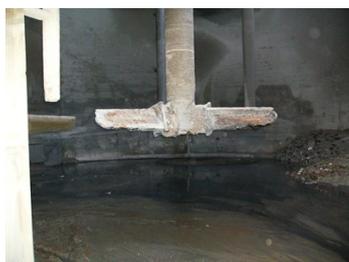
Rubber clad blades damaged through impact and abrasion. Each shaft has three blades and there were four shafts.

Agitator blades in crystallization tank which is an important component of the Flue Gas Desulfurization (FGD) unit.
