Belzona Superwrap System helps maintain cooling system of Naval Vessel engines

Industry: *Marine* Customer Location: *Guam/Hawaii*
Application: *VPF-Valves, Pipes and Fittings* Application Date: *August 2023*
Substrate: *Bronze*
Products: *Belzona 1161 (Super UW-Metal), Belzona 1982 (SuperWrap II)*

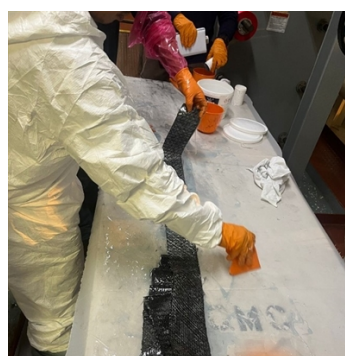
Bronze pipe system with cooling water was set going into the Naval Ship engine room. Pipes had sharp changes and angles causing internal erosion. The customer was worried that the erosion could cause thin wall and compromise the pipes. They needed a compliant pipe repair system that would insure them at least 2 years of life before the pipe would be replaced.

Bronze Alloy Pipes to be wrapped

Some Rebuild had to be done around uneven geometry to leave a smooth area for the SW2 system to go on. Belzona 1161 was used for the rebuild. Surface preparation was done as per SSPC-11 Bare Metal Power tool Cleaning. Surface was cleaned with solvent cleaner and the Superwrap 2 system was applied using the 1982 resin system. A crew of four was used, 2 for mixing and 2 for wrapping. 12 Pipe sections were done in 4 days of work.

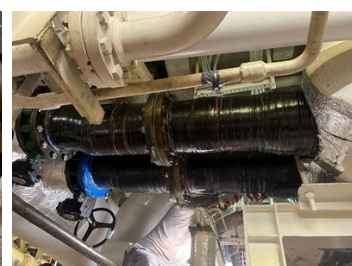
Pipe wrapped and finished as per design with Belzona Superwrap 2 system

Mixing and wetting of the Superwrap 2 inside the ship
