Belzona Superwrap System helps maintain cooling system of Naval Vessel engines

ID: 9272

Industry: Marine
Application: VPF-Valves, Pipes and Fittings
Substrate: Bronze
Products: Belzona 1161 (Super UW-Metal), Belzona 1982 (SuperWrap II)

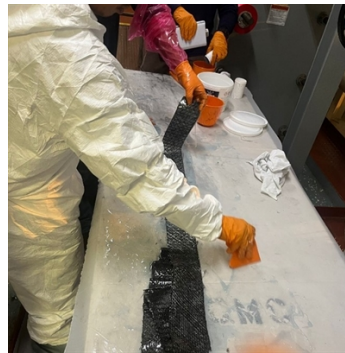
Bronze Alloy Pipes to be wrapped

Mixing and and wetting of the Superwrap 2 inside the ship

Some Rebuild had to be done around uneven geometry to leave a smooth area for the SW2 system to go on. Belzona 1161 was used for the rebuild. Surface preparation was done as per SSPC-11 Bare Metal Power tool Cleaning. Surface was cleaned with solvent cleaner and the Superwrap 2 system was applied using the 1982 resin system. A crew of four was used, 2 for mixing and 2 for wrapping. 12 Pipe sections were done in 4 days of work.

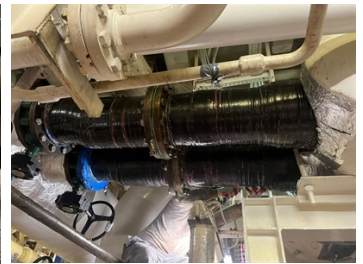
Pipe wrapped and finished as per design with Belzona Superwrap 2 system
