# Belzona Superwrap System helps maintain cooling system of Naval Vessel engines

ID: 9272

Industry: *Marine* Customer Location: *Guam/Hawaii*  
Application: *VPF-Valves, Pipes and Fittings* Application Date: *August 2023*  
Substrate: *Bronze*  
Products: *Belzona 1161 (Super UW-Metal), Belzona 1982 (SuperWrap II)*

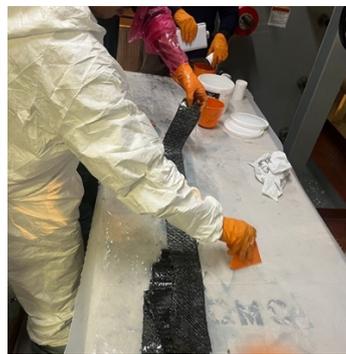
Bronze Alloy Pipes to be wrapped

Some Rebuild had to be done around uneven geometry to leave a smooth area for the SW2 system to go on. Belzona 1161 was used for the rebuild. Surface preparation was done as per SSPC-11 Bare Metal Power tool Cleaning. Surface was cleaned with solvent cleaner and the Superwrap 2 system was applied using the 1982 resin system. A crew of four was used, 2 for mixing and 2 for wrapping. 12 Pipe sections were done in 4 days of work.

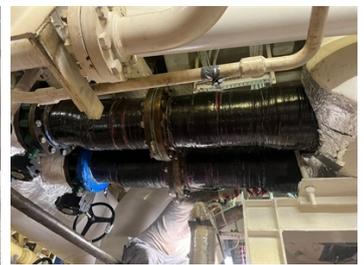
Mixing and wetting of the Superwrap 2 inside the ship
