Belzona Repeatedly Offers Rebuilding and Efficiency Coating Solutions for OEM Pump Manufacturers

Application: CEP-Centrifugal Pumps

Products: Belzona 1111 (Super Metal), Belzona 1341 (Supermetalglide), Belzona 1391T

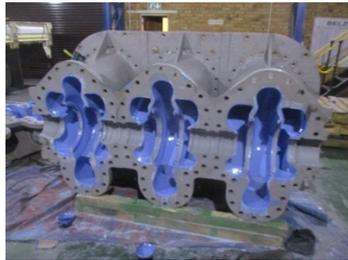
Pump efficiency improved with Belzona 1341 (Supermetalglide)

There has been a variety of work repairing and protecting pumps for this client. In one example, recently repaired a split casing pump for a customer with Belzona 1111 and Belzona 1341. This pump will have a much improved efficiency, thus reducing its Kw's absorbed, reducing amps, and saving our customer money which in a country with massive power problems is a necessity. Belzona 1391T was also used on pumps that did not require efficiency improvement.

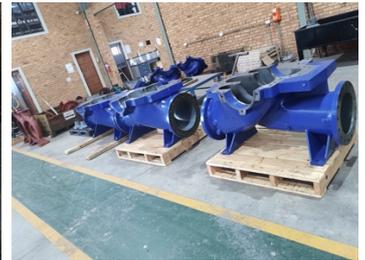
Split casing pump repaired and protected with Belzona

We stress that when executed correctly, our repairs not only save clients money but also ensure durability. Notably, our rapid turnaround time is a key differentiator, aligning seamlessly with our sales approach. Instead of resorting to OEM line boring for a split casing pump, we advocate for casting wear rings and bushes back into place. This alternative proves to be both more economical and faster than the conventional machining of the pump, a methodology we have successfully implemented numerous times to the satisfaction of our clients.
