BELZONA MAINTAINS FRANCIS TURBINE

Customer Location: Power Plant, Honduras, Central America
Application Date: November 2006

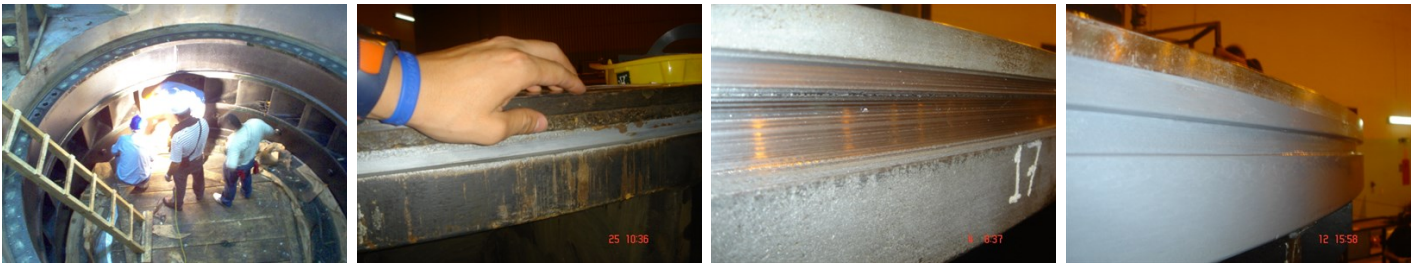
Photograph Descriptions

The water had produced an erosion/corrosion effect in several sections of four different parts of the Turbine. The biggest damage was located in the seal perimeter of the facing plate.

- * View of diffusers ,
- * Damage in seal perimeter ,
- * Machined area prior application of Belzona® 1111 ,
- * Final application of Belzona® 1111 and Belzona® 1321 ,

Complete Overhaul of all the parts and sections of a Francis Turbine. The turbine needed maintenance after 15 years of operation.

Repairs were carried out utilizing Belzona Know-How System Leaflets CEP-4, CEP-5 and ENC-5.

The customer decided to make a complete maintenance using Belzona's products after we had repaired the shaft in 2004 with excellent results. The actual damaged part had a diameter of 3.8 m which was rebuilt, machined and rectified to precise measurements for its assembly.
