# BELZONA MAINTAINS FRANCIS TURBINE

ID: 928

Customer Location: Power Plant, Honduras, Central America  
Application Date: November 2006

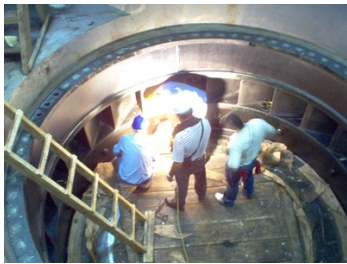
- \* View of diffusers ,
- \* Damage in seal perimeter ,
- \* Machined area prior application of Belzona® 1111 ,
- \* Final application of Belzona® 1111 and Belzona® 1321 ,

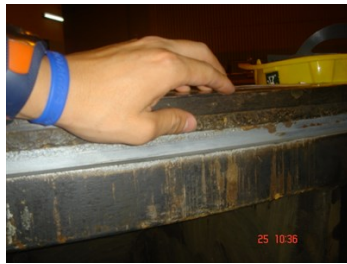
*The water had produced an erosion/corrosion effect in several sections of four different parts of the Turbine. The biggest damage was located in the seal perimeter of the facing plate.*

The customer decided to make a complete maintenance using Belzona's products after we had repaired the shaft in 2004 with excellent results. The actual damaged part had a diameter of 3.8 m which was rebuilt, machined and rectified to precise measurements for its assembly.
