Belzona System Protects Ebonite Tanks

ID: 9281

Application: TCC-Tanks and Chemical Containment Areas

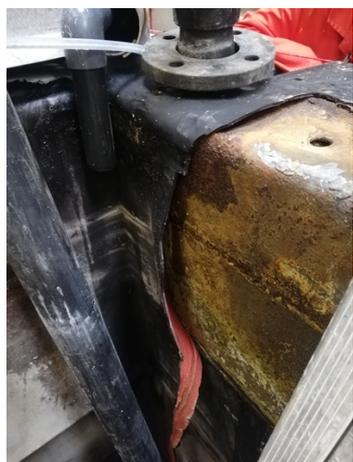
A global aluminium manufacturing company has been experiencing degradation to their Ebonite-coated steel tanks which were subject to chemical attack in the form of sulphuric acid. The acid had caused the ebonite to break down and then create holes in the tank.

Ebonite tank suffering from degradation

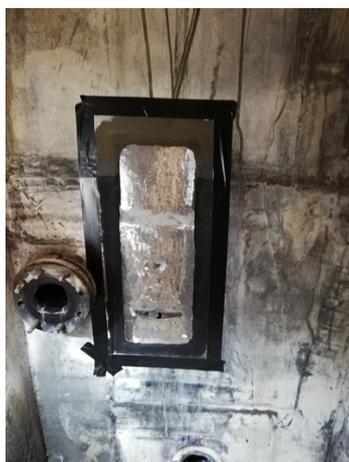
Surface prepared and area taped off, ready for application

To apply the products, the damaged existing coating had to be removed and the surface grinded to Swedish Standard Sa 2½ and minimum profile of 75µ.

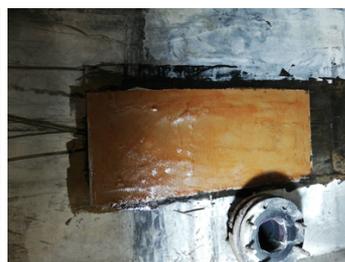
Finished application

A combination of different Belzona products has been recommended to offer the best solution for the repair. Belzona 1111 for resurfacing the substrate back to original profile where it has been damaged by corrosion and chemical attack, Belzona 1981 and Belzona 9371 for reinforcing the substrate with fibreglass where the wall was too thin or had holes, and Belzona 1392 for protection from further damage of the same kind. This combination was chosen because it is resistant to 30% concentrated sulphuric acid, but also because Belzona 1392 can resist higher temperatures in case of spikes and can be applied in a thicker coat. Important key points for the client were also the speed of the repair (they could only afford limited downtime and the Belzona solution could be applied in only 3 or 4 days), the durability of the repair and low cost.
