# Belzona Repairs and Protects Vacuum Pumps from Chemical Attack

Application: CEP-Centrifugal Pumps

Customer Location: Rayong, Thailand

Application Date: March 2016

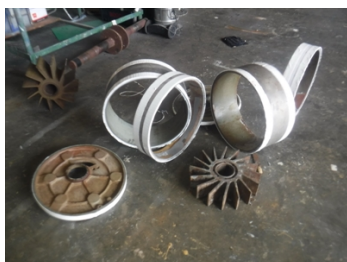
The vacuum pumps in oil and gas industry were damaged by Chlorobenzene (CB) attack.

Disassembled pump components

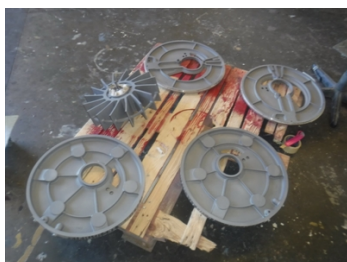
After sand blasting

1. The vacuum pumps were disassembled into its individual components in preparation for repair.
2. The surface preparation was done by sand blasting.
3. The pump components were rebuilt with Belzona 4301 and coated with Belzona 4311.
4. After the products were fully cured, the repairs were machined back to their original dimension before reassembling.

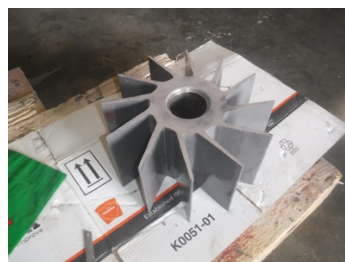
The impeller rebuilt with Belzona 4301

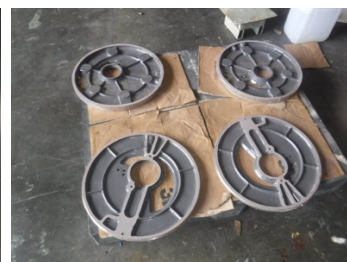
The suction and discharge disks after coating with Belzona 4311
