# Belzona Repairs and Protects Vacuum Pumps from Chemical Attack

ID: 9284

Application: CEP-Centrifugal Pumps

Application Date: March 2016

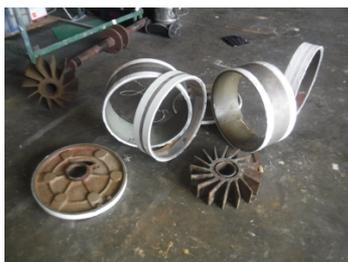
The vacuum pumps in oil and gas industry were damaged by Chlorobenzene (CB) attack.

Disassembled pump components

1. The vacuum pumps were disassembled into its individual components in preparation for repair.
2. The surface preparation was done by sand blasting.
3. The pump components were rebuilt with Belzona 4301 and coated with Belzona 4311.
4. After the products were fully cured, the repairs were machined back to their original dimension before reassembling.

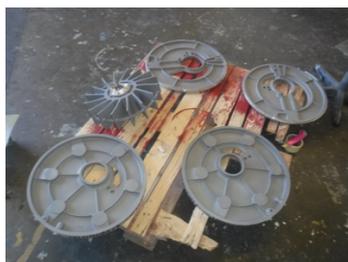
After sand blasting

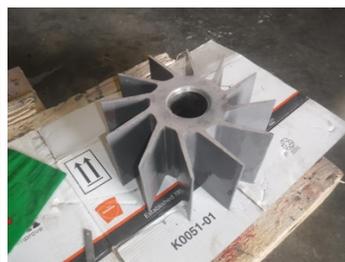
The impeller rebuilt with Belzona 4301

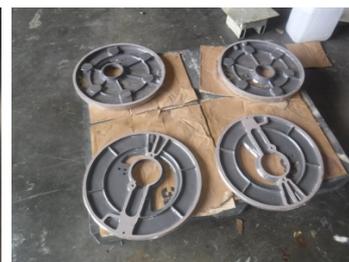
The suction and discharge disks after coating with Belzona 4311
