RESTORING AND COATING E5B HEAT EXCHANGER FACE

ID: 9288

Application: *HEX-Heat Exchangers*

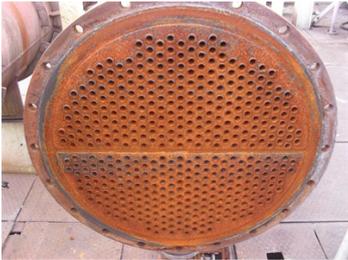
1.) Before application

Galvanic corrosion on the tube face, caused by contact of 2 dissimilar metals.

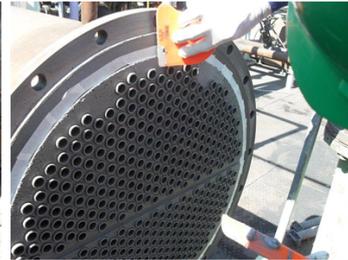
2.) After Blasting

The application area was marked out before the tube face was grit blasted to SA2.5, achieving a minimum 75-micron profile. After blasting, the tube face was rebuilt with Belzona 1111, followed by 2 coats of Belzona 1321, each coat was applied at 250-375 microns. After the Belzona had cured, a visual inspection was carried out and any areas requiring touch-ups were marked up, abraded, and then re-coated.
