# RESTORING AND COATING E5B HEAT EXCHANGER FACE

ID: 9288

Application: HEX-Heat Exchangers

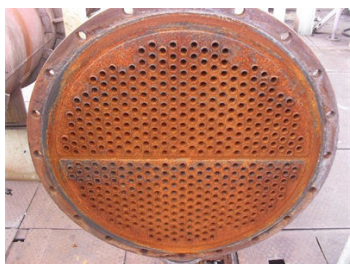
*Galvanic corrosion on the tube face, caused by contact of 2 dissimilar metals.*

1.) Before application

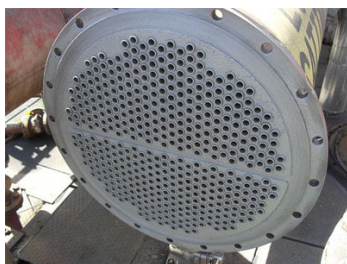
2.) After Blasting

The application area was marked out before the tube face was grit blasted to SA2.5, achieving a minimum 75-micron profile. After blasting, the tube face was rebuilt with Belzona 1111, followed by 2 coats of Belzona 1321, each coat was applied at 250-375 microns. After the Belzona had cured, a visual inspection was carried out and any areas requiring touch-ups were marked up, abraded, and then re-coated.

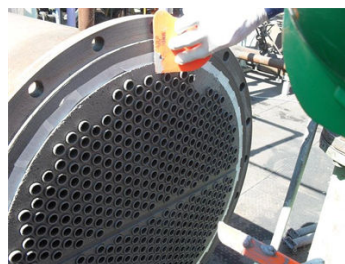
3.) Applying Belzona 1111 for the rebuild

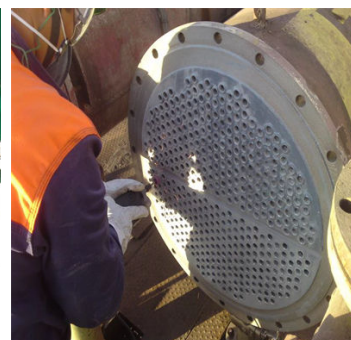
4.) Final application - removal of corks

Before the HEX was put back in service, the equipment passed a hydrostatic test carried out by the client under a pressure of 30 kg/cm<sup>2</sup>.
