BELZONA COATS STACK WHILST IN SERVICE

ID: 929

Customer Location: *North American Galvanizing*
Application Date: *July, 2007*

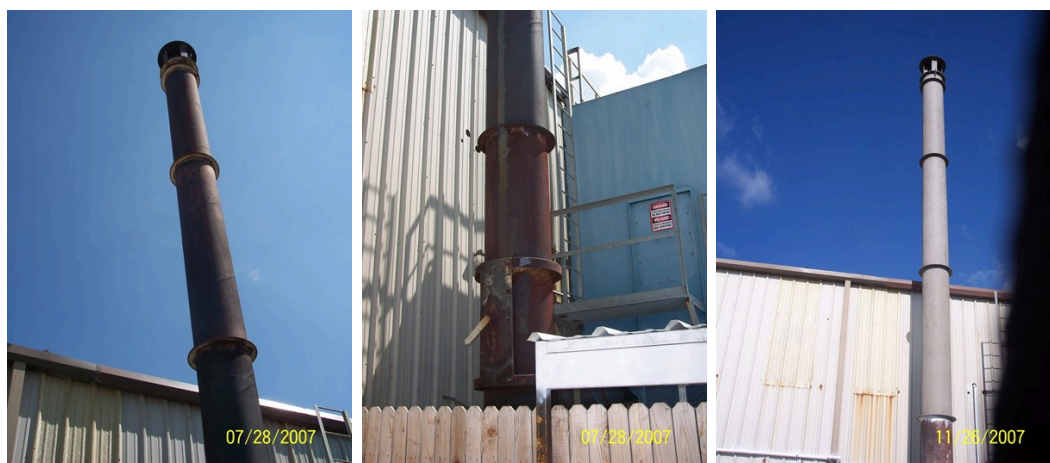
External corrosion protection required but stack could not be taken out of service.

* Original chimney , * Test strip - top portion, bottom - burned portion , * Final application - 4 months later ,

Vent stack for hot gases operating between 300 & 550°F (150 & 280°C) internal temperature.

Brush applied with a 4" bristle brush by hand.

Coating was less expensive than any other alternative considered by customer. It also allowed application without taking chimney out of service saving more time and money. Belzona® 5851 also required no surface preparation saving more time and money.
