BELZONA COATS STACK WHILST IN SERVICE

ID: 929

Customer Location: North American Galvanizing
Application Date: July, 2007

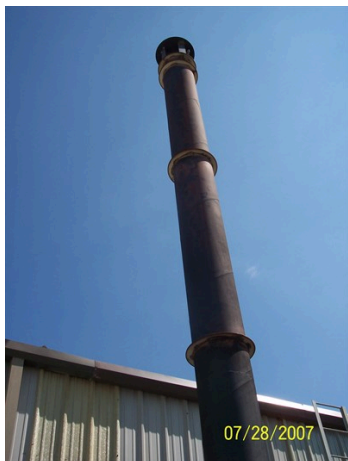
External corrosion protection required but stack could not be taken out of service.

* Original chimney , * Test strip - top portion, bottom - burned portion , * Final application - 4 months later ,

Brush applied with a 4" bristle brush by hand.
