# CO2 Absorber Rubber Lining Replaced with Belzona Coating System

**Industry:** Power  
**Application:** TCC-Tanks and Chemical Containment Areas  
**Substrate:** Carbon steel  
**Products:** Belzona 1331, Belzona 5811 (Immersion Grade)

**Customer Location:** RAS LAFFAN, QATAR  
**Application Date:** December 2023

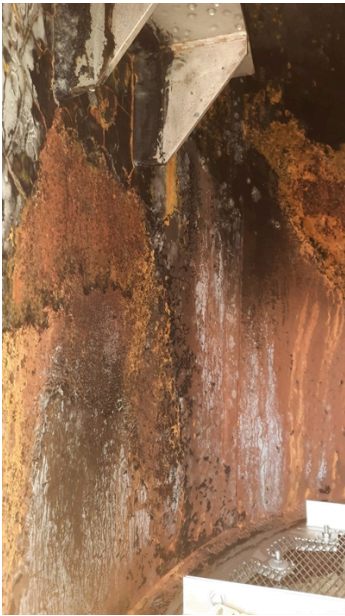
The rubber lining of the CO2 absorber was swelling, blistering and crackings throughout the tank interior. Corrosion damage to the base metal was so pronounced that it could be glimpsed through cracked/delaminated rubber lining.

Traces of severe corrosion from under the rubber lining

The damaged rubber lining was replaced with a Belzona epoxy coating system. The original system thickness requirement by the customer was a minimum of 2 mm, as the previous rubber lining was 3 mm thick. The proposal initially considered was a 2 mm thick build-up with Belzona 1111, but it was too costly and over budget to cover the entire interior surface, so Belzona 5811 was used for the build-up instead of Belzona 1111.

Three coats of Belzona 5811 (Immersion Grade) were applied as filler and to cover the wall loss. Belzona 1331 was applied as the final top coat.

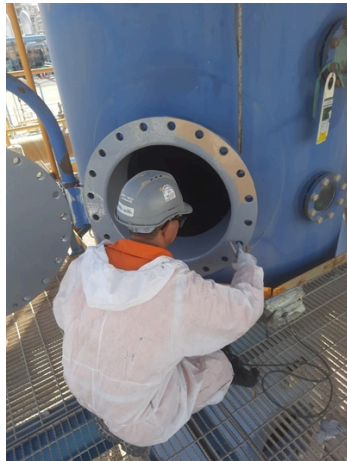
Coating application in progress to the manway and flange

Each coat was applied using an airless spray machine. The materials were applied in accordance with the relevant Instruction For Use and the guidance of approved method statement.

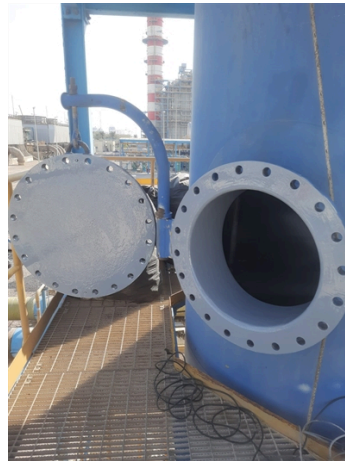
Manway and flange coated and protected

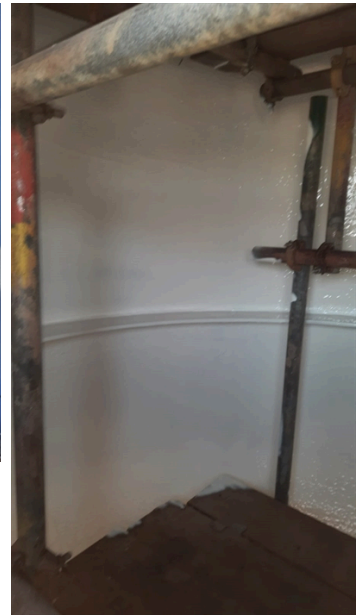
Protected tank interior after application

Almost all internal surfaces had pitting and Belzona 5811 was applied directly to the substrate to fill and seal the pitted, uneven surfaces without the use of smoothing paste grade material. Belzona 1331, applied as a topcoat on the premise of contact with the medium, offers excellent erosion/corrosion resistance and a long service life.
