Belzona 4111 Fills the Concrete Cracks in Warehouse Floor to Maintain Safety in Workplace

Application: FPA-Floor Problem Areas

Substrate: Concrete

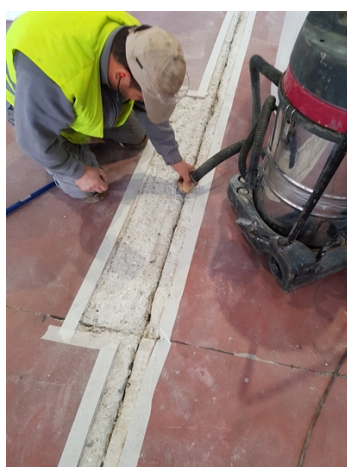
Cleaning after the preparation to remove dust and small debris

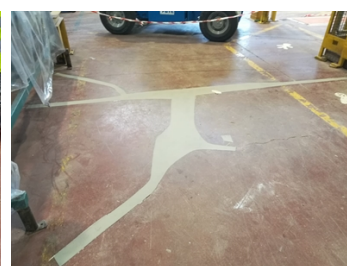
Complete repair on a warehouse floor
