Belzona 4111 Fills the Concrete Cracks in Warehouse Floor to Maintain Safety in Workplace

ID: 9291

Application: FPA-Floor Problem Areas

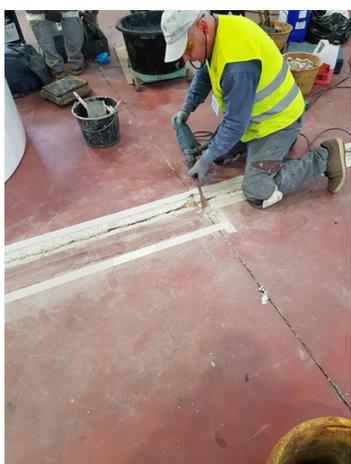
Remove detached concrete pieces and prepare grooves for repair along the crack lines

To address damaged joints and cracks in the floor, a V-shaped groove needs to be cut out which is filled with Belzona 4111 (magma-quartz) mixture. Grooves are dug for each section, typically 6 mm to 10 mm deep, depending on the width and depth of the cracks. Exposed concrete surfaces were thoroughly prepared with a scarifier. After removing dust and impurities, the grooves were conditioned with Belzona 4911 (Magma TX conditioner). Finally, the mixed Belzona 4111 (Magma Quartz) was applied directly to the conditioned surface and finished by trowelling to smooth the surface.

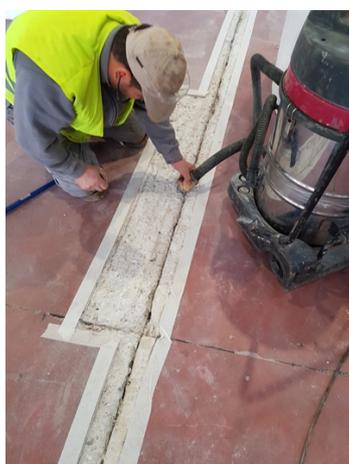
Cleaning after the preparation to remove dust and small debris

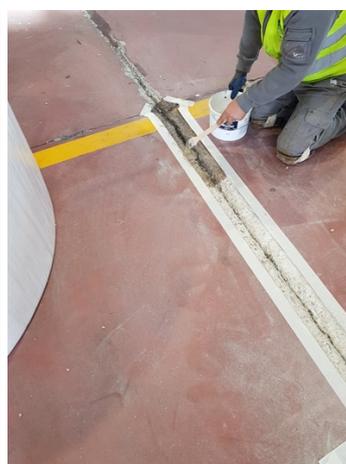
Belzona 4911 Conditioner applied to the exposed concrete substrate in the repaired area

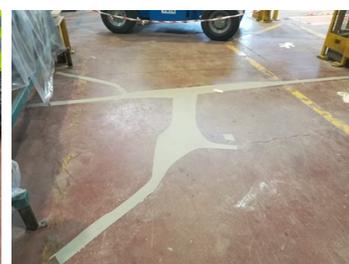
Complete repair on a warehouse floor

Belzona 4111 (Magma-Quartz) was chosen to address this problem in floor areas due to its excellent adhesion to concrete, outstanding mechanical properties, quick return to service and long-term durability, effectively preventing the problem from recurring.
