# Belzona Repairs Ballast Tank Perforations at Port Service Facility

**Industry:** Marine  
**Application:** TCC-Tanks and Chemical Containment Areas  
**Substrate:** Other  
**Products:** Belzona 1818, Belzona 4111 (Magma-Quartz), Belzona 4151 (Magma-Quartz Resin), Belzona 5811 (Immersion Grade), Belzona 5831LT

**Customer Location:** France  
**Application Date:** August 2023

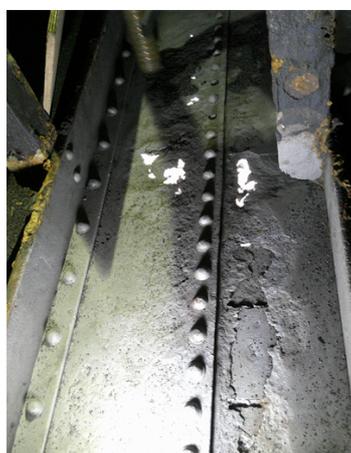
The ballast tanks at this port service facility were suffering from corrosion due to exposure to seawater. Previously, metal pads had been welded to repair perforations in the tank. However, this triggered bimetallic corrosion, apart from the original problem of saltwater corrosion. As a result, the corrosion continued and extended around the weld bead and under the welded pads, resulting in through-wall defects.

Extensive damage revealed at the tank bottom after blasting

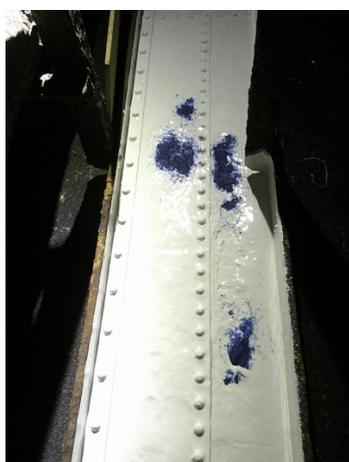
First coated throughout with Belzona 5831LT and pit filled with Belzona 1818

After surface preparation by blasting, Belzona 5811 and 5831LT were applied to the prepared surfaces; Belzona 5811 was applied to the dry areas and Belzona 5831LT to the damp areas. Belzona 1818 was then applied to fill voids and low spots over the applied coating. As a final finishing touch to the repair, a resin rich mix of Belzona 4151 and silica aggregate was poured over the repaired areas to reinforce and level out the bottom.

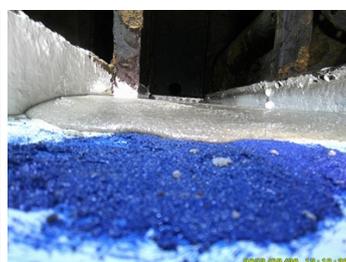
Belzona 4151-silica mixture was poured over Belzona 5831LT and 1818

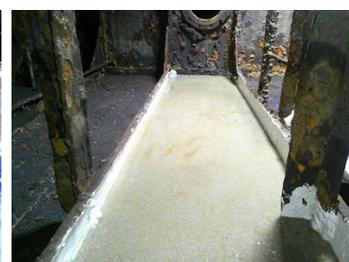
Complete application
