JET FUEL Tank's Pitting Corrosion

ID: 9294

Application: TCC-Tanks and Chemical Containment Areas

Substrate: Carbon steel

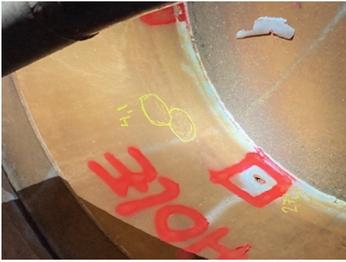
The Jet fuel tank had 14 points with pitting . The refinery wanted to fill up the tank with Jet fuel ASAP .

Big pitting with hole

We used Belzona 9611 for the big holes and then Belzona 1161 to cover the pitting .

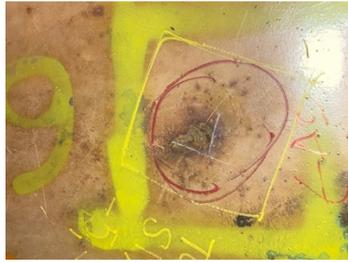
pitting

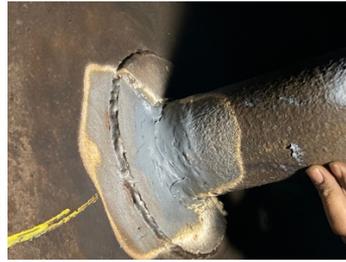
After the application of Belzona 1161

At the end we use Belzona 5811 for long term chemical resistance .

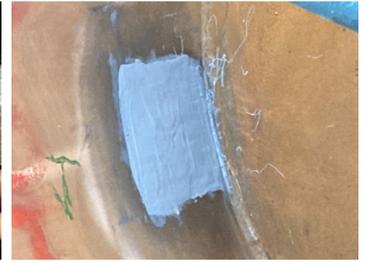
Hole after the application
