Belzona Protects Ship Exhaust

ID: 9296

Industry: Marine
 Application: VPF-Valves, Pipes and Fittings
 Substrate: Stainless-steel
 Products: Belzona 1391T, Belzona 9111 (Cleaner Degreaser)

Customer Location: Turkey
 Application Date: 2020

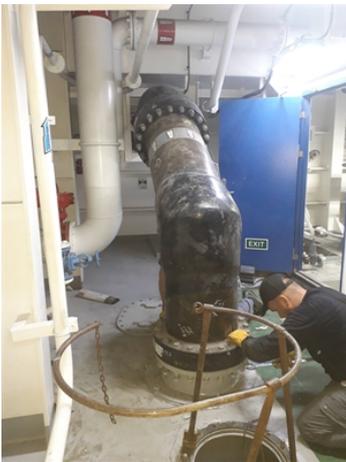
The steel pipe affected by scrubber exhausted emissions

Belzona 1391T, a high-temperature corrosion-resistant coating, was chosen to protect the affected steel pipes during a scrubber retrofit installation.

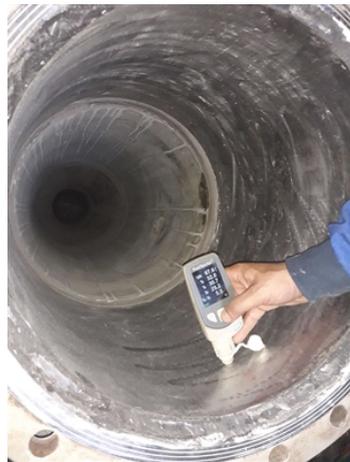
Surface Preparation

Before the project started, the surface climate conditions, salt content, and profile depth were closely monitored to ensure optimal results prior to the application. The sub-contractors and applicators underwent training, and the application began with cleaning the area using Belzona 9111 (Cleaner Degreaser). Following surface preparation an application of two coats of Belzona 1391T was followed by a careful post-curing process according to the provided instructions.

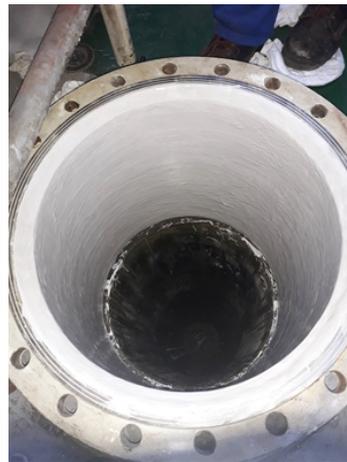
Finished application after two coats of Belzona 1391T

The application was completed over the course of one day, with an allowance of additional working hours for the post curing process. Heaters and dehumidifiers were used inside a tented area in order to ensure a controlled environment was achieved.

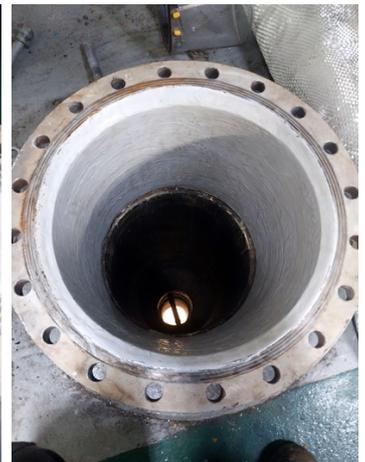
Application after being inspected two years later.

Since the process was done in 2020, the Distributor has revisited the ship and found that all of the coated scrubber passage pipes were found in perfect condition. The customer was happy and satisfied with the Belzona solution chosen.
