Extending life of Cement ball mill using Belzona products

ID: 9299

Industry: *Cement*
Application: *SHM-Solids Handling Machinery*

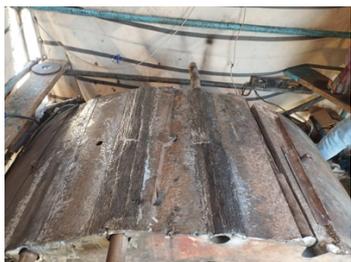
A cement ball mill was subjected to abrasions caused by the entrapment of cement particles under the mill tiles.

Damaged ball mill surface

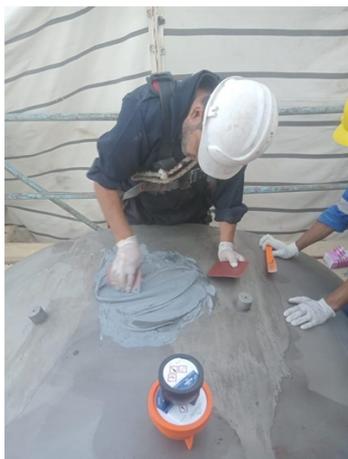
Applying Belzona 1111

- The Tiles are removed from the surface of the ball mill
- The surface below is roughened to ensure maximum adhesion and then cleaned with a non-residual cleaner.
- The tile is then brushed with Belzona 9411 release agent
- Belzona 1111 is applied to the surface below the tile and the tile is aligned and left to cure accordingly

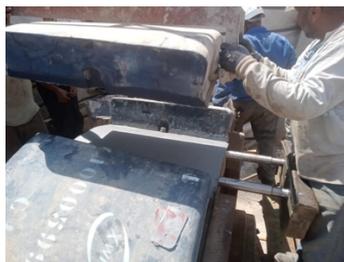
Aligning the tiles to be used as a mould

The Belzona solution is much easier, faster and needs no machining as we use the tile itself as a mould to restore the worn surfaces

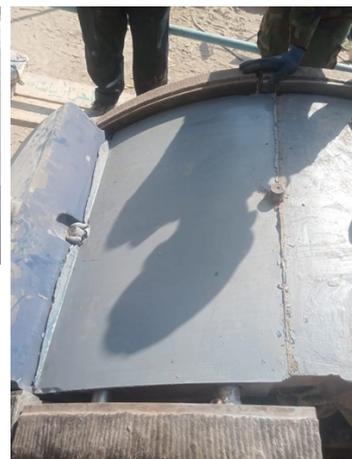
Application Complete
