Extending life of Cement ball mill using Belzona products

ID: 9299

Industry: *Cement*
Application: *SHM-Solids Handling Machinery*

Substrate: *Carbon steel*
Products: *Belzona 1111 (Super Metal)*

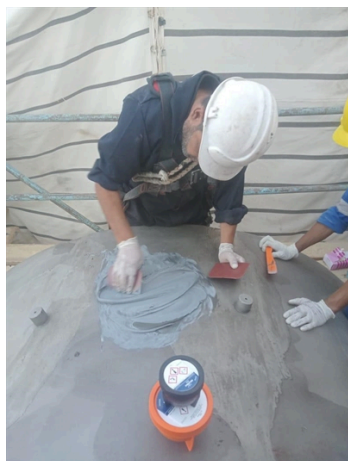
Applying Belzona 1111

- The Tiles are removed from the surface of the ball mill
- The surface below is roughened to ensure maximum adhesion and then cleaned with a non-residual cleaner.
- The tile is then brushed with Belzona 9411 release agent
- Belzona 1111 is applied to the surface below the tile and the tile is aligned and left to cure accordingly

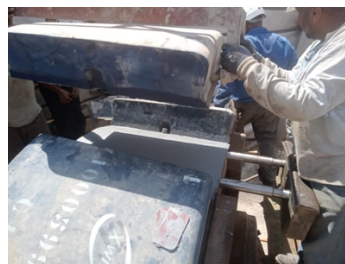
Aligning the tiles to be used as a mould

The Belzona solution is much easier, faster and needs no machining as we use the tile itself as a mould to restore the worn surfaces

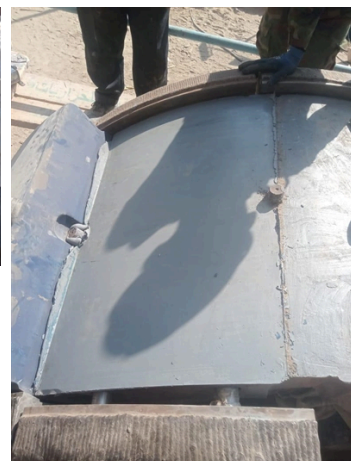
Application Complete
