# REPAIR AND PROTECTION OF OIL/WATER SEPARATOR WITH BELZONA

Industry: Oil & Gas  
Application: TCC-Tanks and Chemical Containment Areas  
Substrate: Steel  
Products: \* Belzona® 1111 ,  
\* Belzona® 1391 ,

Customer Location: Major oil production company  
Application Date: 1995

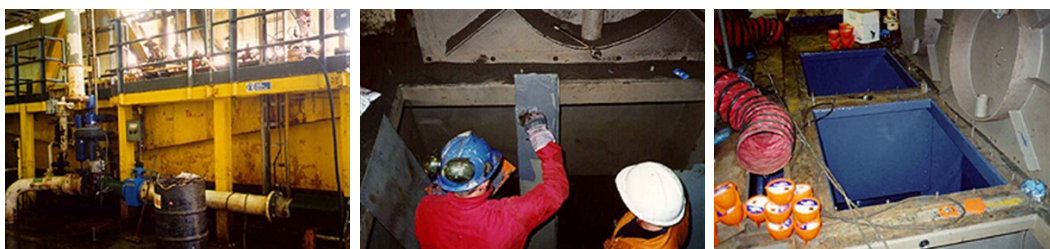
The original glass flake system failed in the severe erosion-corrosion conditions leading to holing of the unit

- \* General view of the unit ,
- \* Bonding doubler plates to holed areas ,
- \* Belzona® 1391 providing complete protection to the separator internal surfaces ,

Application was carried out in accordance with Belzona® system leaflets TCC-1, TCC-2 & TCC-5. Doubler plates were bonded over holed and deeply pitted areas before applying Belzona® 1391 to provide erosion-corrosion protection over the entire area.
