BELZONA PROVIDES INTERNAL PROTECTION OF GEARBOXES

ID: 930

Customer Location: Oil Refinery, UK
Application Date: November 2007

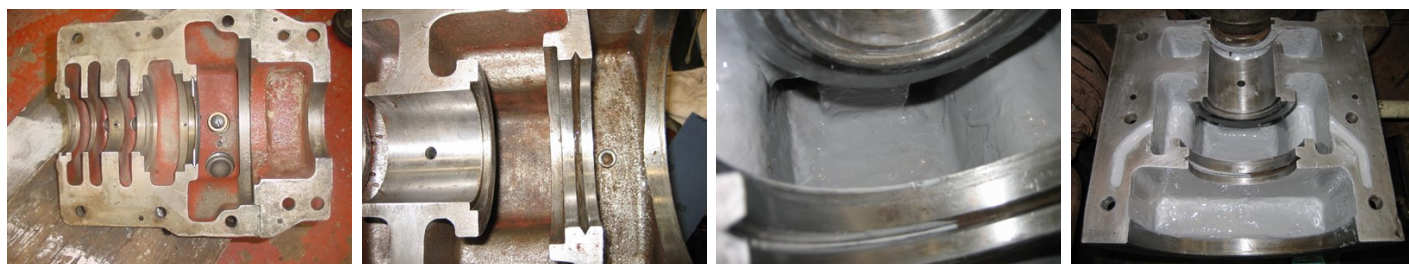
Photograph Descriptions

Original internal paint protection is flaking off and getting stuck in bearings and oilways. Loss of oil circulation can result in bearing damage and reduced efficiency.

- * Gearbox casing with damaged internal coating ,
- * Close up view of degraded paint coating ,
- * Close up view of Belzona 5891 coating ,
- * Completed coating on casing ,

Application carried out in accordance with Belzona Know-How System Leaflet TCC-5.

Paint systems giving life expectancy of 1-3 years. Cost of a major repair caused by damage to the internal parts of the gearbox from flaked paint could run into thousands of pounds for labour, downtime, loss of production and parts. Belzona coating provides long term corrosion protection and resists hot oil without flaking.
