# Belzona Repairs a Transformer

ID: 9301

Industry: Power  
Application: GSS-Gaskets, Seals and Shims  
Substrate: Carbon steel  
Products: Belzona 1161 (Super UW-Metal), Belzona 5831 (ST-Barrier), Accessories

Customer Location: Amsterdam  
Application Date: January 2024

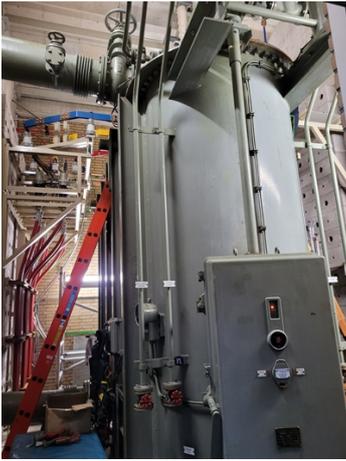
Transformer to be repaired.

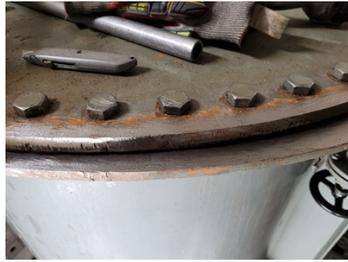
A large transformer in Amsterdam showed leaks on the flange face of the cover. Since the cover is full of connections and connections, it is not possible to detach the cover and thus replace the gasket.

Area of the transformer leaking.

The transformer is cooled with cooling oil, which does not allow the surface to be completely grease-free. With the Belzona products it is possible to repair the flange face without removing the cover or experiencing problems with the surface.

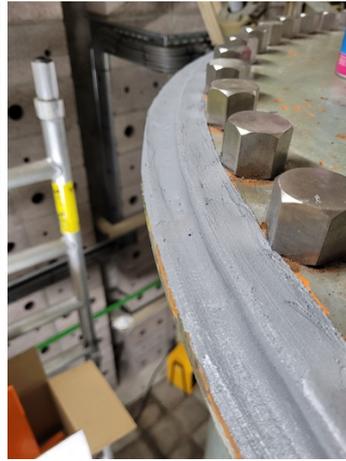
Belzona 1161 applied

Before the Belzona products can be applied, it is important that the surface is cleaned and roughened. The edges are then sealed with the oil-tolerant paste for metal repair, the Belzona 1161. This is applied in combination with the Belzona 9341 reinforcement sheet.

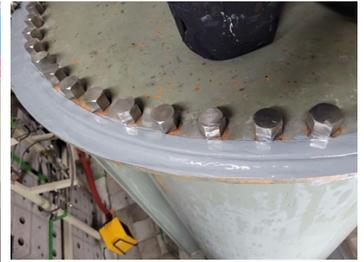
Application complete with a coating of Belzona 5831 over the Belzona 1161

The repair is finished with Belzona 5831 for extra protection. This epoxy coating for corrosion protection is again oil tolerant. The combination of products used repairs the transformer, in such a way that it will be leak-free for a long time. The application was carried out in accordance with Belzona system leaflet GSS-08.
