Fast Curing Belzona Solutions for CUI on Tanks

ID: 9303

Industry: Chemical & Petrochemical
Application: TCC-Tanks and Chemical Containment Areas
Substrate: Carbon steel
Products: Belzona 5892

Customer Location: Belgium
Application Date: February 2024

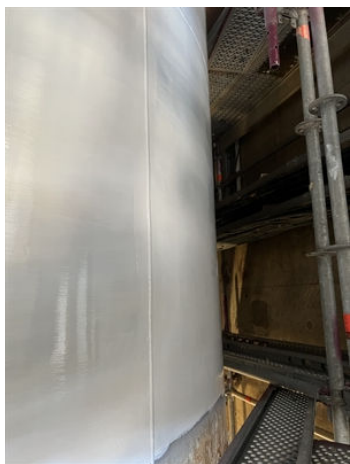
First coat of Belzona 5892 in white.

Two coats of Belzona 5892 were then applied on the same day, providing the customer with significant savings in time. The installation was then installed on top of the coating.

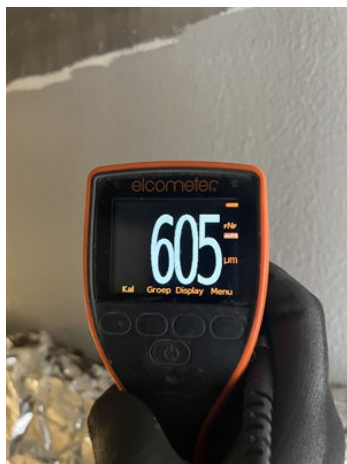
Completed application with coating thickness being checked.

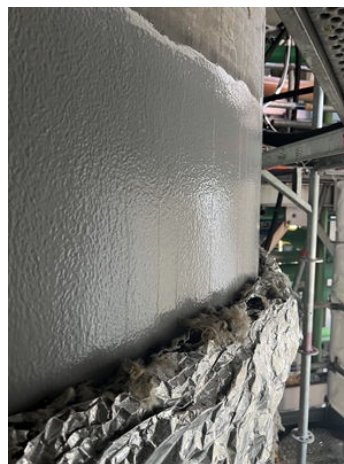
Completed coating with insulation reinstalled.
