Belzona Elastomer Restores an Expansion Joint in a Public Swimming Pool

ID: 9306

Application: FPA-Floor Problem Areas

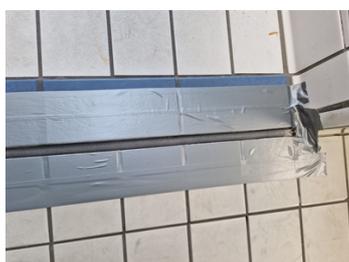
Measurement of the defective expansion joint in order to calculate the required quantity of product.

The old silicone expansion joint was removed and a grinder was used to prepare the surface for the application of Belzona. The area of defective joint was measured to calculate the product required to complete the application. Masking tape was utilised to properly mark and delineate the application area and to maintain a clean finish.

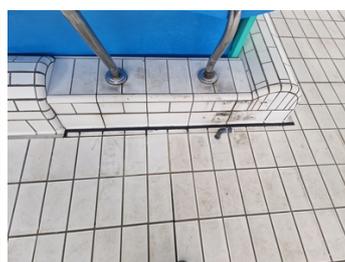
The application area was marked with tape to delimit the application area. A backer rod was inserted into the joint prior to the application of Belzona 2211.

Belzona 2211 filled the expansion joint, safeguarding the concrete structure underneath from further damage.

A thin layer of Belzona 2911 (Elastomer QD Conditioner) was applied to the prepared surface and allowed to dry before a backer rod was inserted into the joint. Humidity level was also checked using a hygrometer to ensure suitable atmospheric conditions for the application.

Belzona 2211 (MP Hi-Build Elastomer) was then thoroughly mixed and applied to the joint to form a new expansion joint.
