Belzona 1812 protects newly fabricated screw conveyor.

ID: 9314

Application: SHM-Solids Handling Machinery

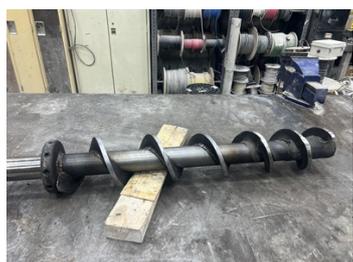
Screw conveyor before surface preparation.

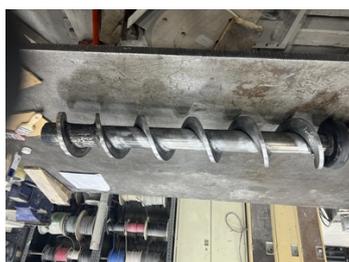
After surface preparation.

Surface preparation with MBX bristle blaster, grinder and solvent cleaning with Belzona 9111.

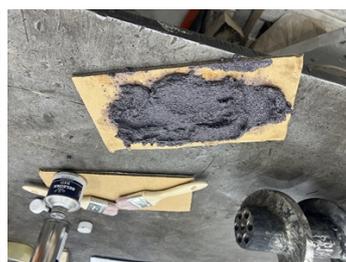
Mixed Belzona 1812.

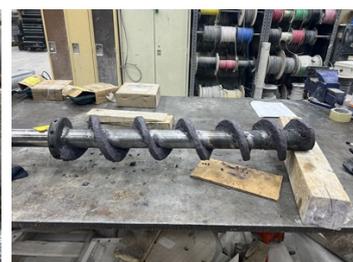
After application of Belzona 1812.

Equipment wears out fast due to abrasion and replacement wait time is long. Belzona solution reduced downtime.
