Bow Thruster Tunnel Repair

ID: 9315

Industry: *Marine*
Application: *SOS-Ships and Offshore Structures*

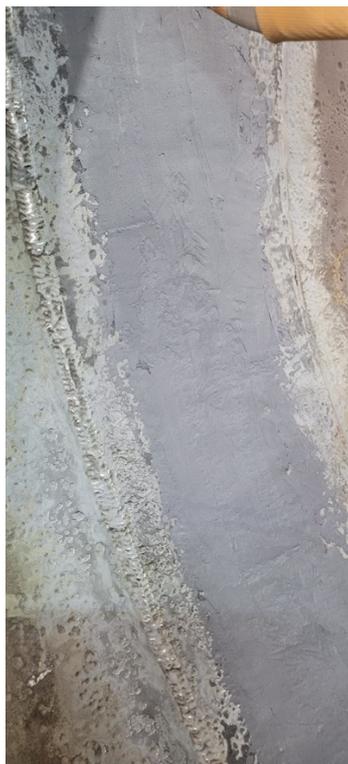
Deep pitting on the bow thruster tunnel due to cavitation

After surface preparation and rebuilding with Belzona 1311

Surface preparation was carried out using the MBX bristle blaster, degreased and allowed to dry. Pitting was filled with Belzona 1311 and two coats of Belzona 1321 was applied.

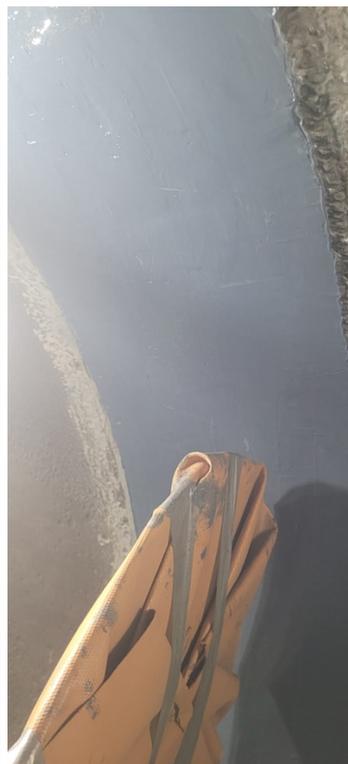
With first coat of Belzona 1321

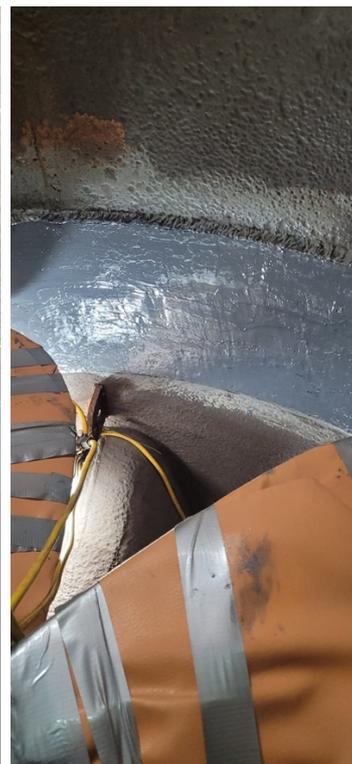
With second coat of Belzona 1321
