Belzona Repairs Concrete Well Base

Industry: Water / Wastewater
Application: FPA-Floor Problem Areas
Substrate: Concrete
Products: Belzona 4111 (Magma-Quartz), Belzona 4911 (Magma TX Conditioner), Belzona 5821

Customer Location: Portugal
Application Date: 2023

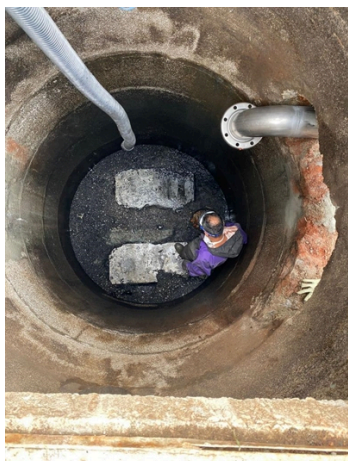
The concrete base was suffering from chemical attack caused by the waste in the process fluid. The bottom of the well was so severely damaged that the two pumps at housed there were in danger of detaching from their anchor points.

The damaged concrete area

For surface preparation, we used high pressure water cleaning and an electric hammer to break the old concrete. The surface was then cleaned, and all debris removed. A water vacuum cleaner was used to remove the remaining water trapped in holes. All areas to be repaired were blown with compressed air in order to remove as much water as possible and ensure that the surface was dry. It was not expected to find such large holes at the bottom. As a solution, the holes were filled with gravel in conjunction with Belzona 4911 (Magma TX Conditioner). This was done to ensure the stability of the bottom after curing. After this, Belzona 4911 (Magma TX Conditioner) was applied on the rest of the substrate, followed by Belzona 4111 (Magma-Quartz) at about 1,5 cm thickness.

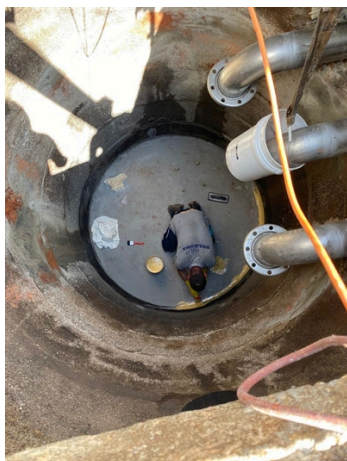
Applying Belzona 4111 (Magma Quartz) and Belzona 5821

Belzona 5821 was then used on the second day to line the well and offer protection from chemical attack, erosion and immersed conditions. The maintenance team first installed the screws for the base of the pumps, then Belzona 5821 was applied. The application of Belzona 5821 was done by brush on the periphery of the well and around the screws. After that, the application was done with a spatula to guarantee a greater thickness in a single application.
