# Belzona Repairs Concrete Well Base

Industry: Water / Wastewater  
Application: FPA-Floor Problem Areas  
Substrate: Concrete  
Products: Belzona 4111 (Magma-Quartz), Belzona 4911 (Magma TX Conditioner), Belzona 5821

Customer Location: Portugal  
Application Date: 2023

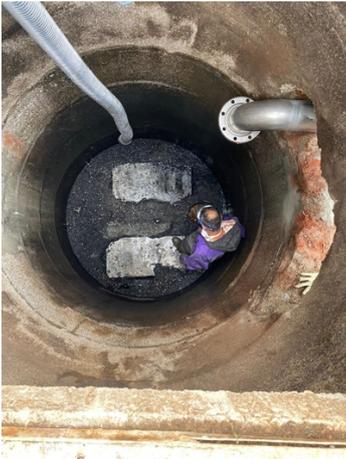
The concrete base was suffering from chemical attack caused by the waste in the process fluid. The bottom of the well was so severely damaged that the two pumps at housed there were in danger of detaching from their anchor points.

The damaged concrete area

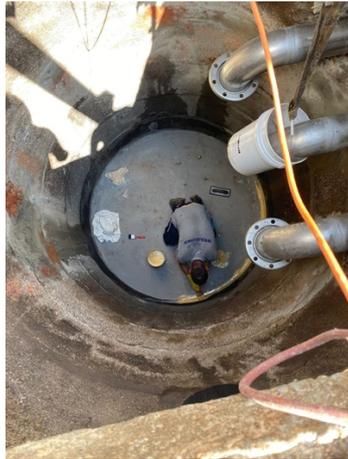
Applying Belzona 4111 (Magma Quartz) and Belzona 5821

For surface preparation, we used high pressure water cleaning and an electric hammer to break the old concrete. The surface was then cleaned, and all debris removed. A water vacuum cleaner was used to remove the remaining water trapped in holes. All areas to be repaired were blown with compressed air in order to remove as much water as possible and ensure that the surface was dry. It was not expected to find such large holes at the bottom. As a solution, the holes were filled with gravel in conjunction with Belzona 4911 (Magma TX Conditioner). This was done to ensure the stability of the bottom after curing. After this, Belzona 4911 (Magma TX Conditioner) was applied on the rest of the substrate, followed by Belzona 4111 (Magma-Quartz) at about 1,5 cm thickness.

Belzona 5821 was then used on the second day to line the well and offer protection from chemical attack, erosion and immersed conditions. The maintenance team first installed the screws for the base of the pumps, then Belzona 5821 was applied. The application of Belzona 5821 was done by brush on the periphery of the well and around the screws. After that, the application was done with a spatula to guarantee a greater thickness in a single application.

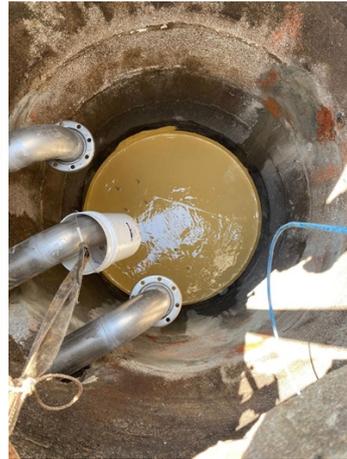
The finished application

The repair is performing well, and the customer is very satisfied. As a result, we have already quoted for a bigger repair.
