Belzona coating provides concrete protection & smooth surface for fish farm

ID: 9318

Industry: Food & Drink
 Application: TCC-Tanks and Chemical Containment Areas
 Substrate: Concrete
 Products: Belzona 5811DW (DW Immersion Grade)

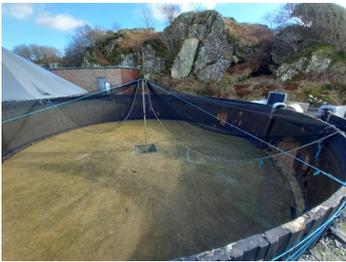
Concrete tanks had been installed & lined years previously with a Polyurea coating which had subsequently failed. This coating had disbonded in large areas & left the concrete open to degradation. The fish stored in the tank could suffer lacerations from the rough surface.

Failed coating

The existing coating was removed & concrete prepared mechanically. Any large gaps or joints were then filled before two coats of Belzona 5811DW2 was applied.

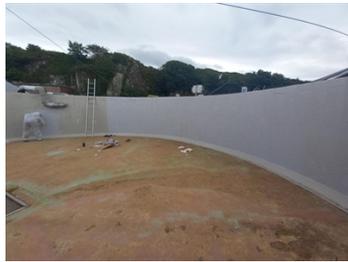
Belzona 5811DW2 application in progress

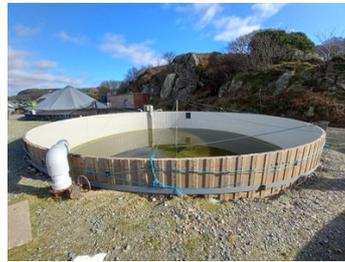
Completed application & filling in progress

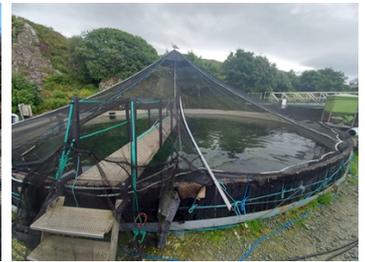
Application in service 12 months
