# Belzona coating provides concrete protection & smooth surface for fish farm

ID: 9318

Industry: Food & Drink  
 Application: TCC-Tanks and Chemical Containment Areas  
 Substrate: Concrete  
 Products: Belzona 5811DW (DW Immersion Grade)

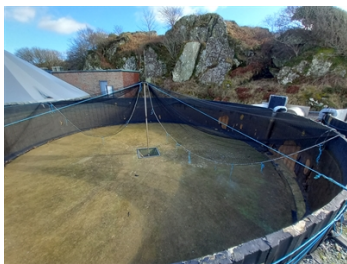
Concrete tanks had been installed & lined years previously with a Polyurea coating which had subsequently failed. This coating had disbonded in large areas & left the concrete open to degradation. The fish stored in the tank could suffer lacerations from the rough surface.

Failed coating

The existing coating was removed & concrete prepared mechanically. Any large gaps or joints were then filled before two coats of Belzona 5811DW2 was applied.

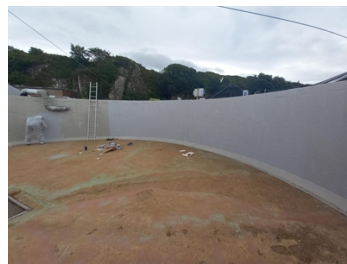
Belzona 5811DW2 application in progress

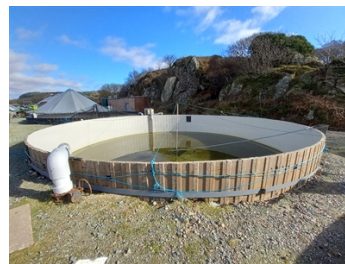
Completed application &amp; filling in progress

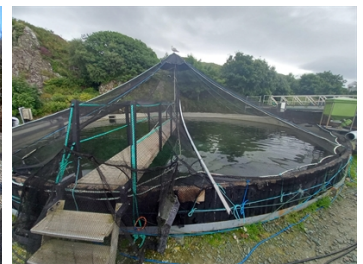
Application in service 12 months
