Belzona Repair Damage to Technical Trenches and Floors

Industry: Power
Application: FPA-Floor Problem Areas
Substrate: Concrete
Products: Belzona 4111 (Magma-Quartz), Belzona 4911 (Magma TX Conditioner)

Customer Location: Portugal
Application Date: September 2024

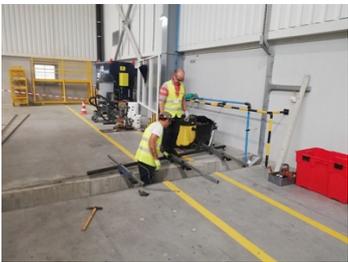
The problem is on the floor of a manufacturing warehouse. They have a problem on the floor of their blade factory, specifically in the joints of the technical trenches, which have metal covers along long lengths. These are found in many passage areas of the pavilion, being subject to impacts, scraping and support of loads from equipment and vehicles that circulate during production. With the movement of employees, equipment and vehicles, the metal rails at the joints are damaged, which can create dangerous situations for employees and damage to vehicles.

Application Situation

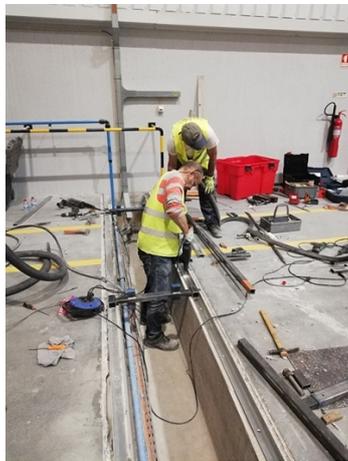
Surface preparation

The repair procedure consists of removing the metal covers, removing the support rails (profile "Z"), opening recesses in the concrete to receive the new "L" shaped support rails (metal angle), applying Belzona 4111 (Magma-Quartz) to the base of laying and fixing them, filling the open spaces in the concrete with Belzona 4111 (Magma-Quartz) always with prior application of 4911 (Magma TX Conditioner) on the base and on the metal gutter "L", finishing the surface with Belzona 4111(Magma-Quartz) to be at floor level.

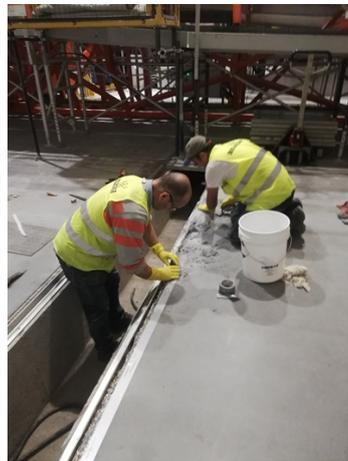
Applying Belzona 4111 (Magma-Quartz)

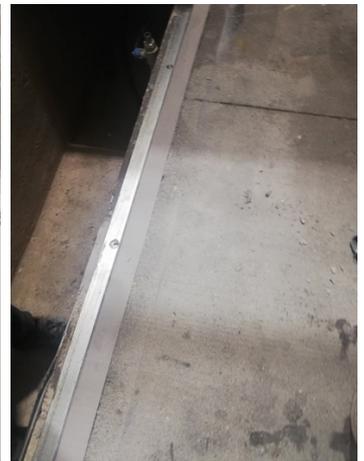
Finished application
