# Belzona 3412 encapsulates Hub Connectors

ID: 9320

Industry: Oil & Gas  
Application: GSS-Gaskets, Seals and Shims  
Substrate: Carbon steel  
Products: Belzona 3412, Belzona 8411

Customer Location: Scotland  
Application Date: August 2020

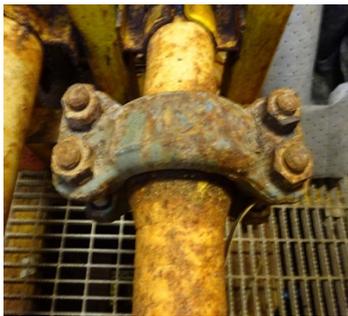
Hub connectors were experiencing corrosion in offshore environments. Within these connectors there are multiple voids where salt water can sit & cause corrosion.

Corroded hub connector

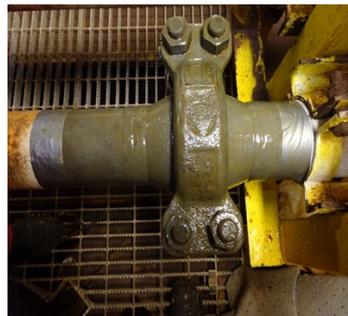
Surface preparation & Belzona 8411 applied

The connector was cleaned & coated with Belzona 8411. Bridging tape was then used to 'fair' and bridge large voids. Two coats of Belzona 3412 were then applied.

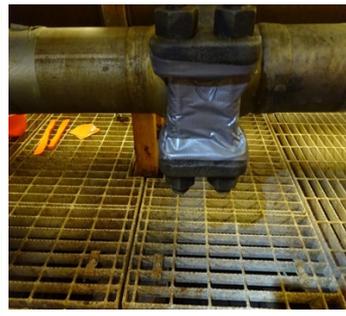
Bridging tape applied around voids

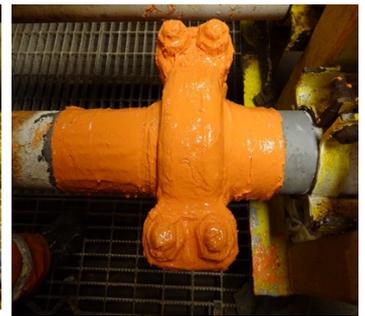
Two coats of Belzona 3412 applied
