Belzona SuperWrap 2 repairs chemical scrubber

ID: 9321

Application: TCC-Tanks and Chemical Containment Areas

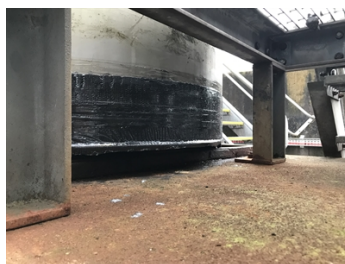
Chemical attack had caused through wall defects within a chemical scrubber. H₂S reacting with water to form sulphuric acid was the main cause.

Through wall defects

The area was first prepared mechanically with an MBX Bristle Blaster. Belzona 1111 & small plates were then used to fair any corroded areas. Four wraps of Belzona SuperWrap II were then applied to reinforce the area.

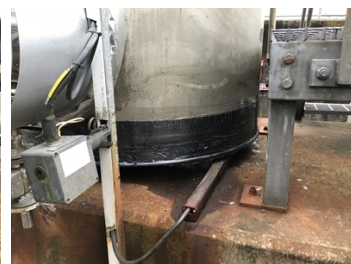
Close up
