Belzona Saves Chiller Head

Application: HEX-Heat Exchangers

Substrate: Carbon steel

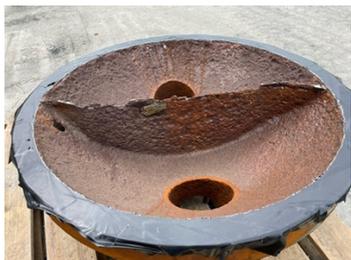
Pre Job Inspection

Chiller head was suffering from severe corrosion/chemical attack due poor water treatment.

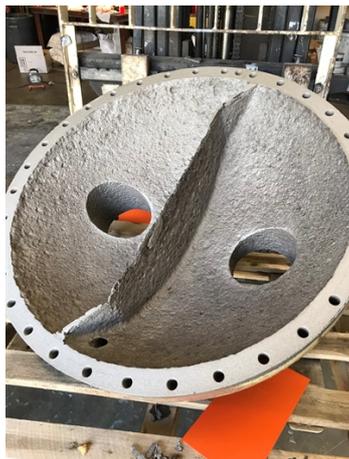
Completion of Abrasive Blasting Rebuild Complete with Belzona 1111

Equipment was abrasive blasted as per manufacture recommendations. Substrate profiles and chlorides were checked for compliance per manufacturer recommendations. Upon completion the application was successfully carried out per HEX-2 guidelines and returned to customer.

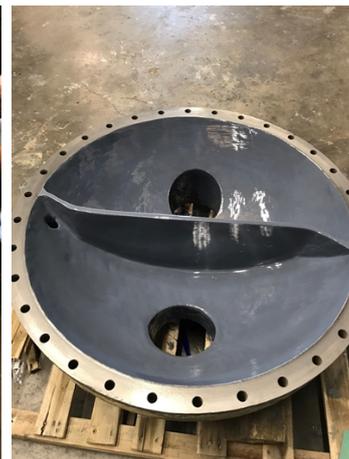
Complete Application with Belzona 1321
