Belzona Saves Chiller Head

Application: HEX-Heat Exchangers

Products: Belzona 1111 (Super Metal), Belzona 1321 (Ceramic S-Metal)

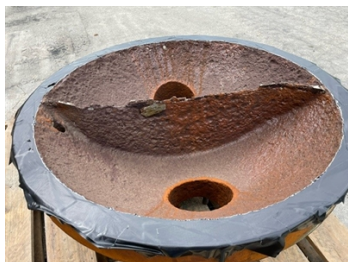
Chiller head was suffering from severe corrosion/chemical attack due poor water treatment.

Pre Job Inspection

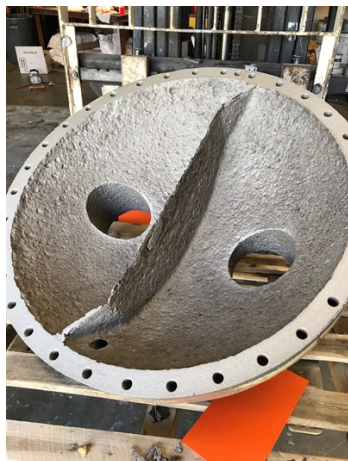
Completion of Abrasive Blasting

Equipment was abrasive blasted as per manufacture recommendations. Substrate profiles and chlorides were checked for compliance per manufacturer recommendations. Upon completion the application was successfully carried out per HEX-2 guidelines and returned to customer.

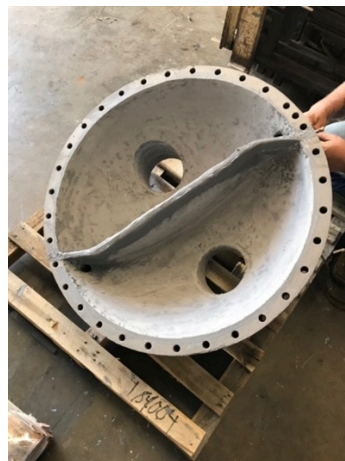
Rebuild Complete with Belzona 1111

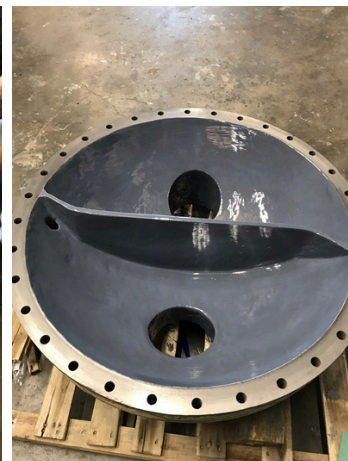
Complete Application with Belzona 1321

Equipment was repaired in 24-48 hrs. with no need for welding or hot work. Due to the fast turn around and repair cost of less than 25% of new, this application proved to be the best option for the client.
